LIGHTWEIGHT LONG LIFE HEAT EXCHANGER

FINAL REPORT

HAMILTON STANDARD

NATIONAL AERONAUTICS AND SPACE ADMINISTRATION

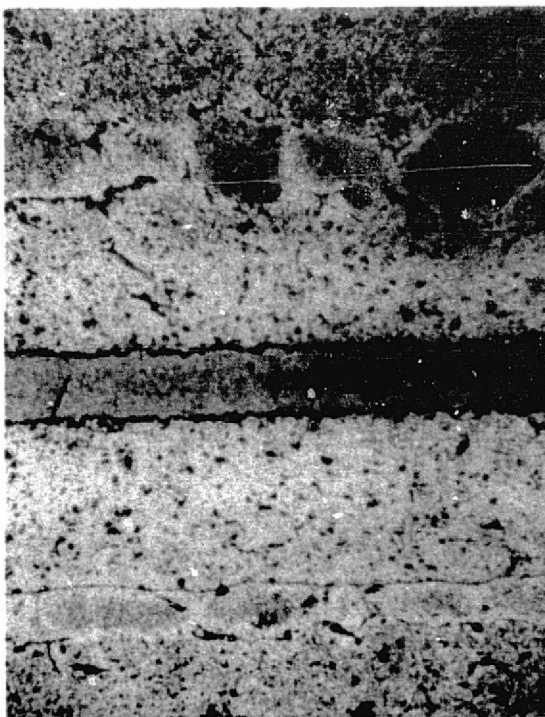
FIGURE 49 MODULE #2 EXAMPLES OF LACK  
OF WETTING AFTER BRAZE
